# Stumble at Wide Open Throttle Takeoff

YEAR(S)	MODEL(S)	ADDITIONAL INFORMATION
2016 - 2018	Tacoma	VDS(s): AZ5CN, BZ5DN, CZ5AN, DZ5BN, EZ5CN, FZ5DN, GZ5AN, HZ5BN, RZ5CN, SZ5AN

Some 2016 – 2018 model year Tacoma vehicles equipped with a 2GR-FKS engine and an automatic transmission may exhibit a stumble at wide open throttle takeoff during operation in a high-altitude area. Follow the Repair Procedure in this bulletin to address this condition.

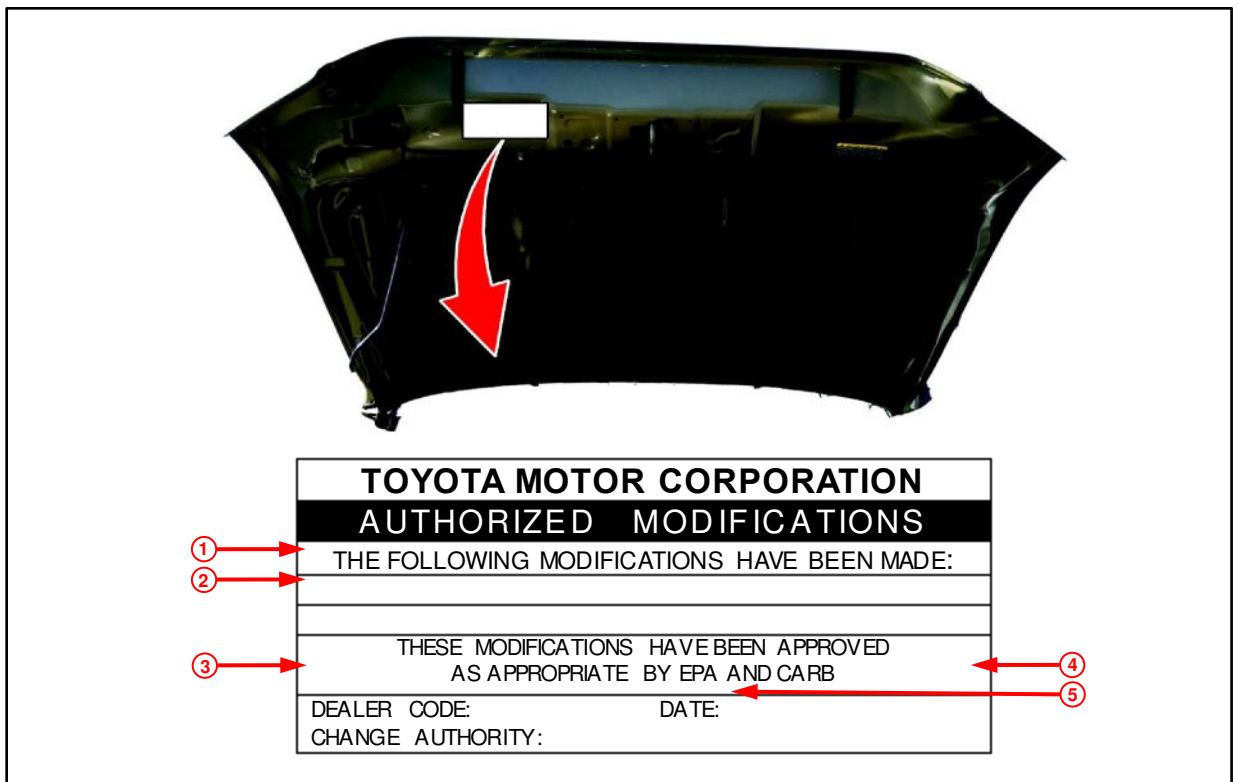
**Figure 1. Location of Authorized Modifications Label for 2016 – 2018 Tacoma**

- Check for the Authorized Modifications Label affixed to the vehicle in the location shown below. Confirm if the ECM (PCM) calibration has been updated.

<b>1</b>	Replacement ECM (PCM) Part Number (e.g., 89661-04K21)
<b>2</b>	New Calibration ID (e.g., 8966304A6100)
<b>3</b>	Dealer Code

<b>4</b>	Date Completed
<b>5</b>	This SB Number

4. Prepare and install the Authorized Modifications Label.
  - A. Using a permanent marker, enter the following information on the label:
    - ECM (PCM) part number [*Refer to the **Parts Information** section for the **NEW PART NUMBER***]
    - Calibration ID(s) [*Refer to the **Calibration Information** section for the **NEW CALIBRATION ID***]
    - Dealer Code
    - Repair Date
    - Change Authority [***This bulletin number***]
  - B. Affix the Authorized Modifications Label to the vehicle at the location shown in Figure 1. The Authorized Modifications Label is available through the MDC, P/N 00451-00001-LBL.
5. Start the engine and test-drive the vehicle to confirm proper operation.
